**- INSPECTION REPORT**  
**NATIONAL DAM SAFETY PROGRAM**

**WAR HORSE PROJECT DAMS**  
**PETROLEUM COUNTY, MONTANA**  
**MAIN DAM MT - 13      WEST DIKE MT - 3208**

**Christian, Spring, Sielbach & Associates**  
**Bozeman, Montana**

**July 1981**

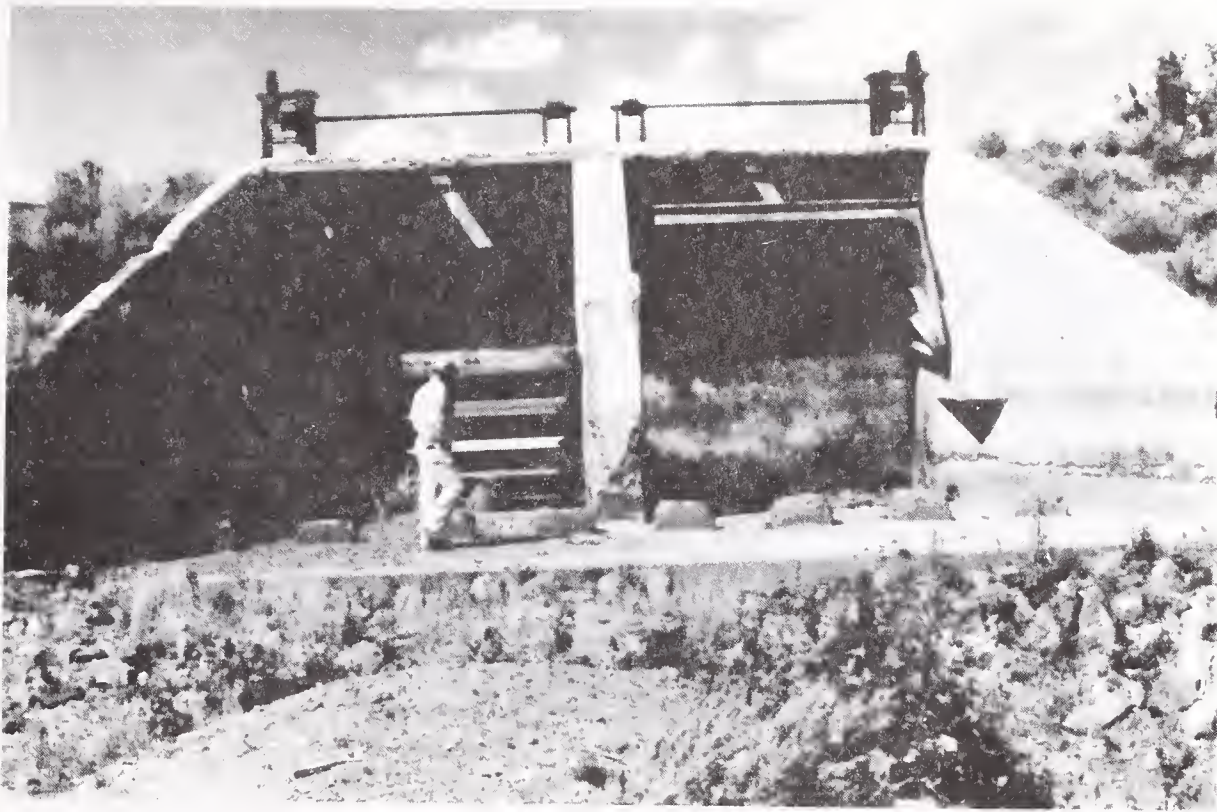
PHOTO 1  
Diversion Dam Tainter Gates

The diversion headworks consists of a dam across Ford's Creek with an earth emergency spillway on the west abutment. A 24-inch-diameter gated pipe extends through the diversion dam and releases flows downstream in Ford's Creek. The diversion structure leading to the canal consists of two 6 X 12 foot tainter gates located just upstream of the east abutment of the dam which control flows into the Diversion Canal. At the time of inspection, one of the tainter gates was in closed position and is considered inoperable (Photo 1).

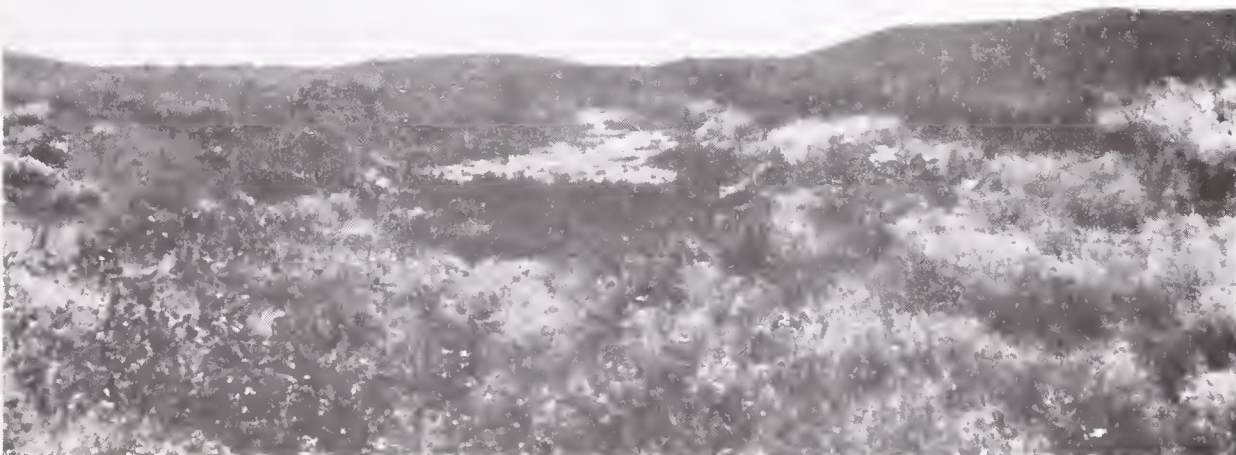
PHOTO 12  
Buffalo Creek Supply Canal

channel from the lake to the breach has a 12-foot bottom width and variable side slopes of nearly 1V on 2H. (Photo 12) Because the approach channel from the reservoir "inlet" is on a long slightly adverse grade, the maximum flows that could be discharged through the breach is dependent upon the capacity of the approach channel. During the routing of an extreme flood event flow could be expected to be coming from the Buffalo Creek diversion toward the reservoir. This flow would severely restrict flow that could be generated from reservoir head toward the breach. The breach would function as an "emergency" spillway when reservoir levels are sufficient to cause flow toward the breach. No other uncontrolled spillway exists in the project. The outfall from the "emergency" spillway is a broad, sloping hillside. (Photo 14) Vegetation on the spillway exit is characterized as "sparse." Soil materials at the breach crest and in the exit channel area appear to be highly erodible. However, because of its location, such erosion as may be caused by prolonged flows through the breach would not endanger the dam embankment. Because of the questionable viability in routing the spillway design flood, no discharge rating curve was developed for the breach.

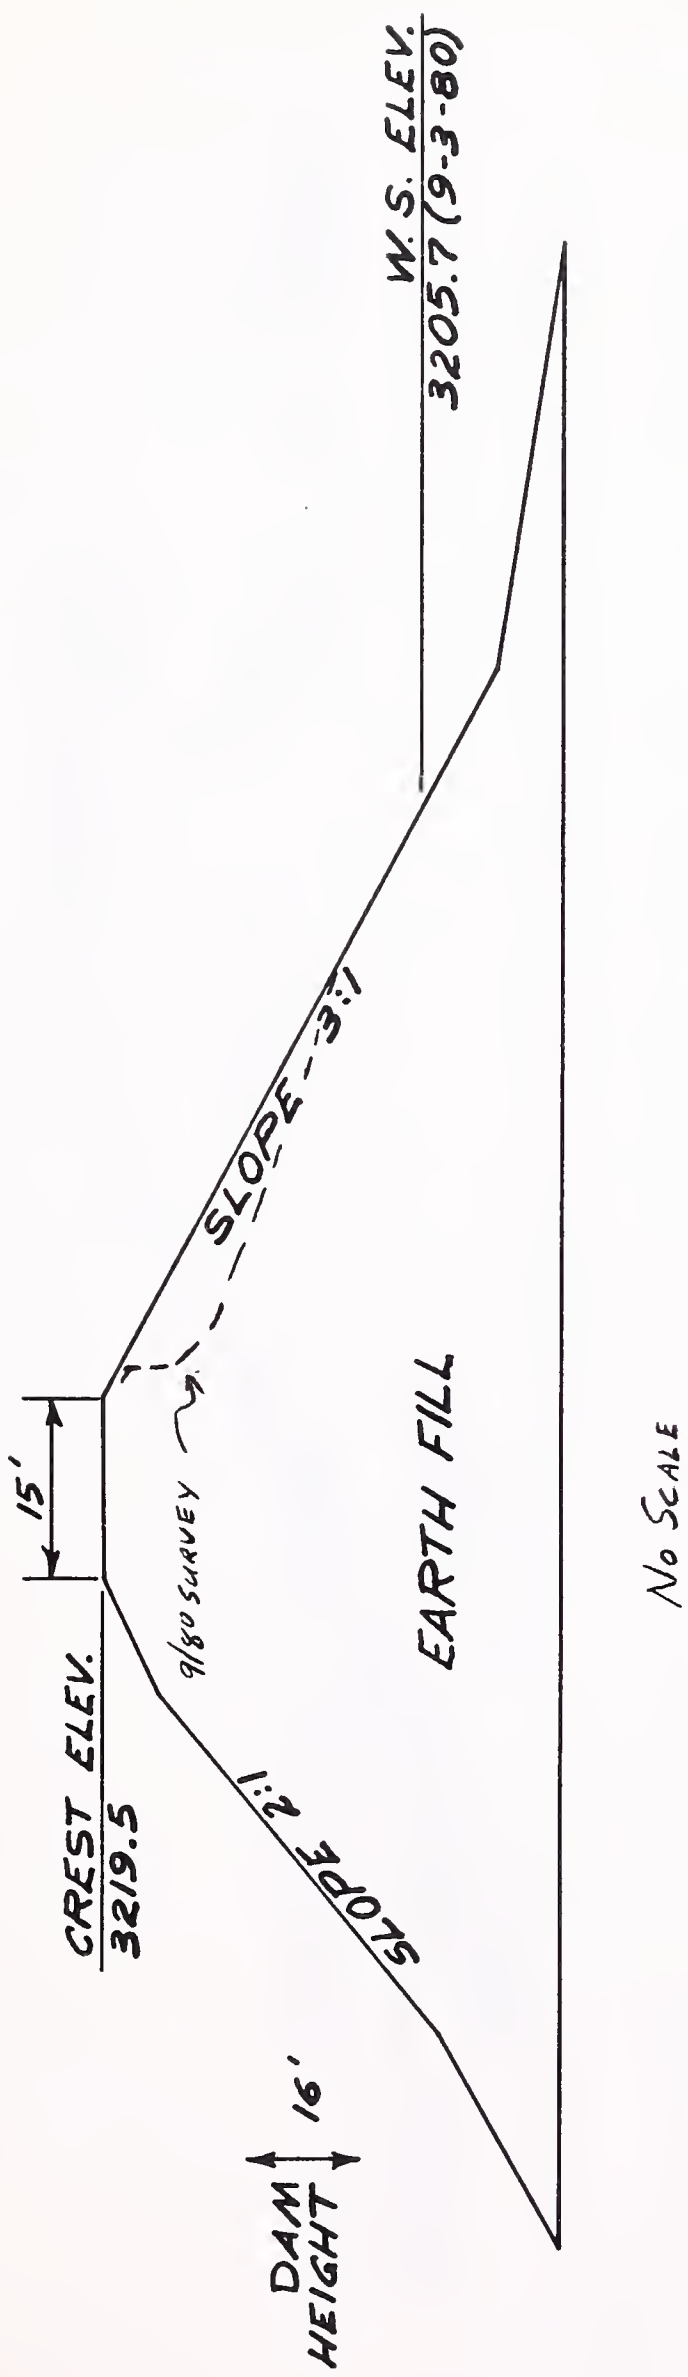
PLATE -3-  
WAR HORSE DAM  
WEST DAM SECTION

The dike is approximately 2700 feet in length, has a maximum height of 16 feet, and a crest width of 12 feet. (Plate 3) At the time of inspection, the pool elevation was about 14 feet below the dike crest.

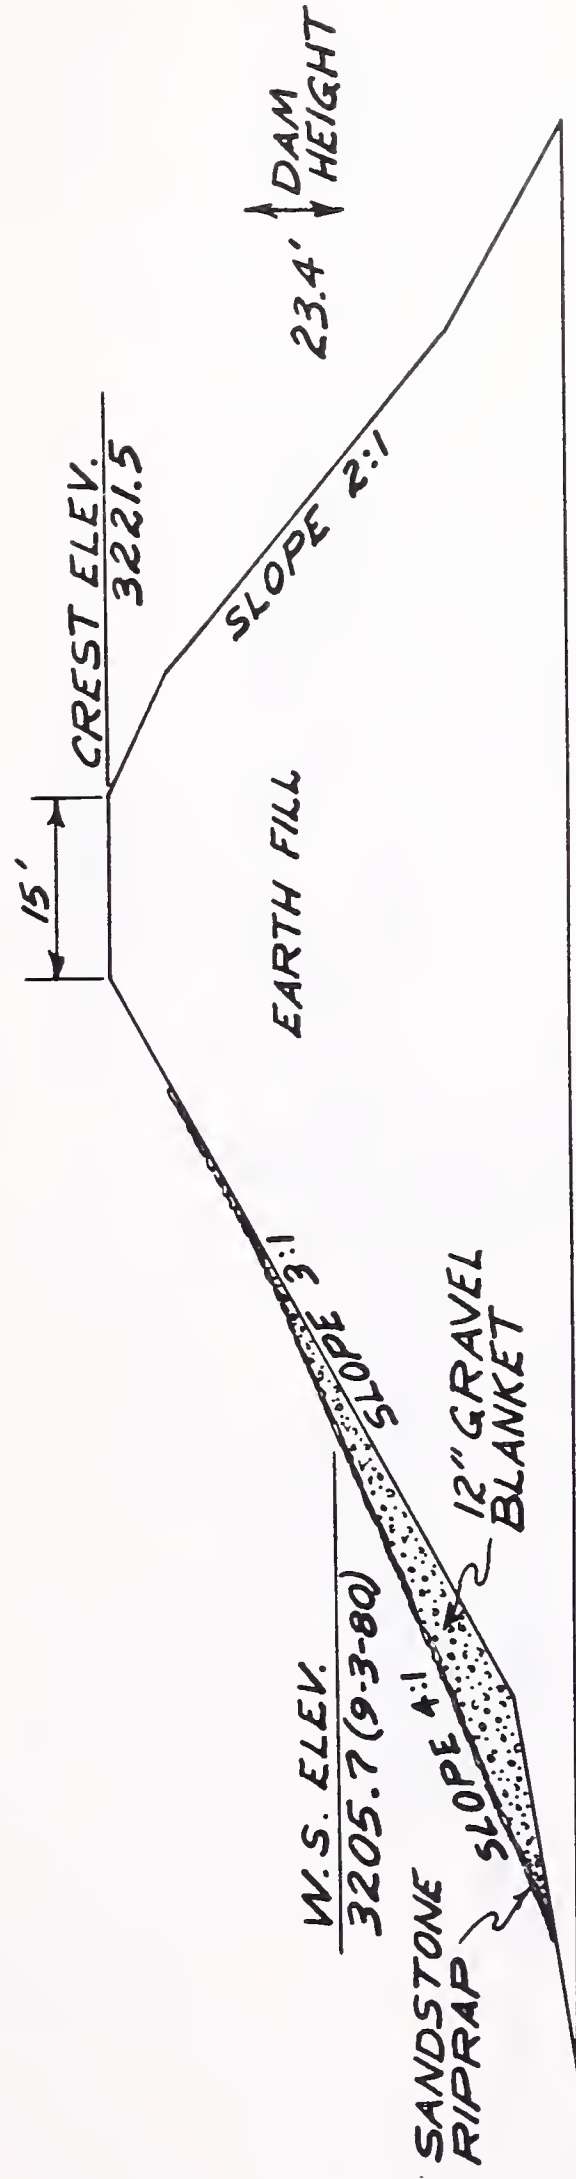
WAR HORSE DAM  
MAIN DAM SECTION

The dam, located at the east end of the reservoir, is approximately 1,950 feet in length and has a maximum height of about 24 feet above existing ground. The crest width is 15 feet. (Plate 4) At the time of inspection, the water level in the reservoir was approximately 16 feet below the dam crest.

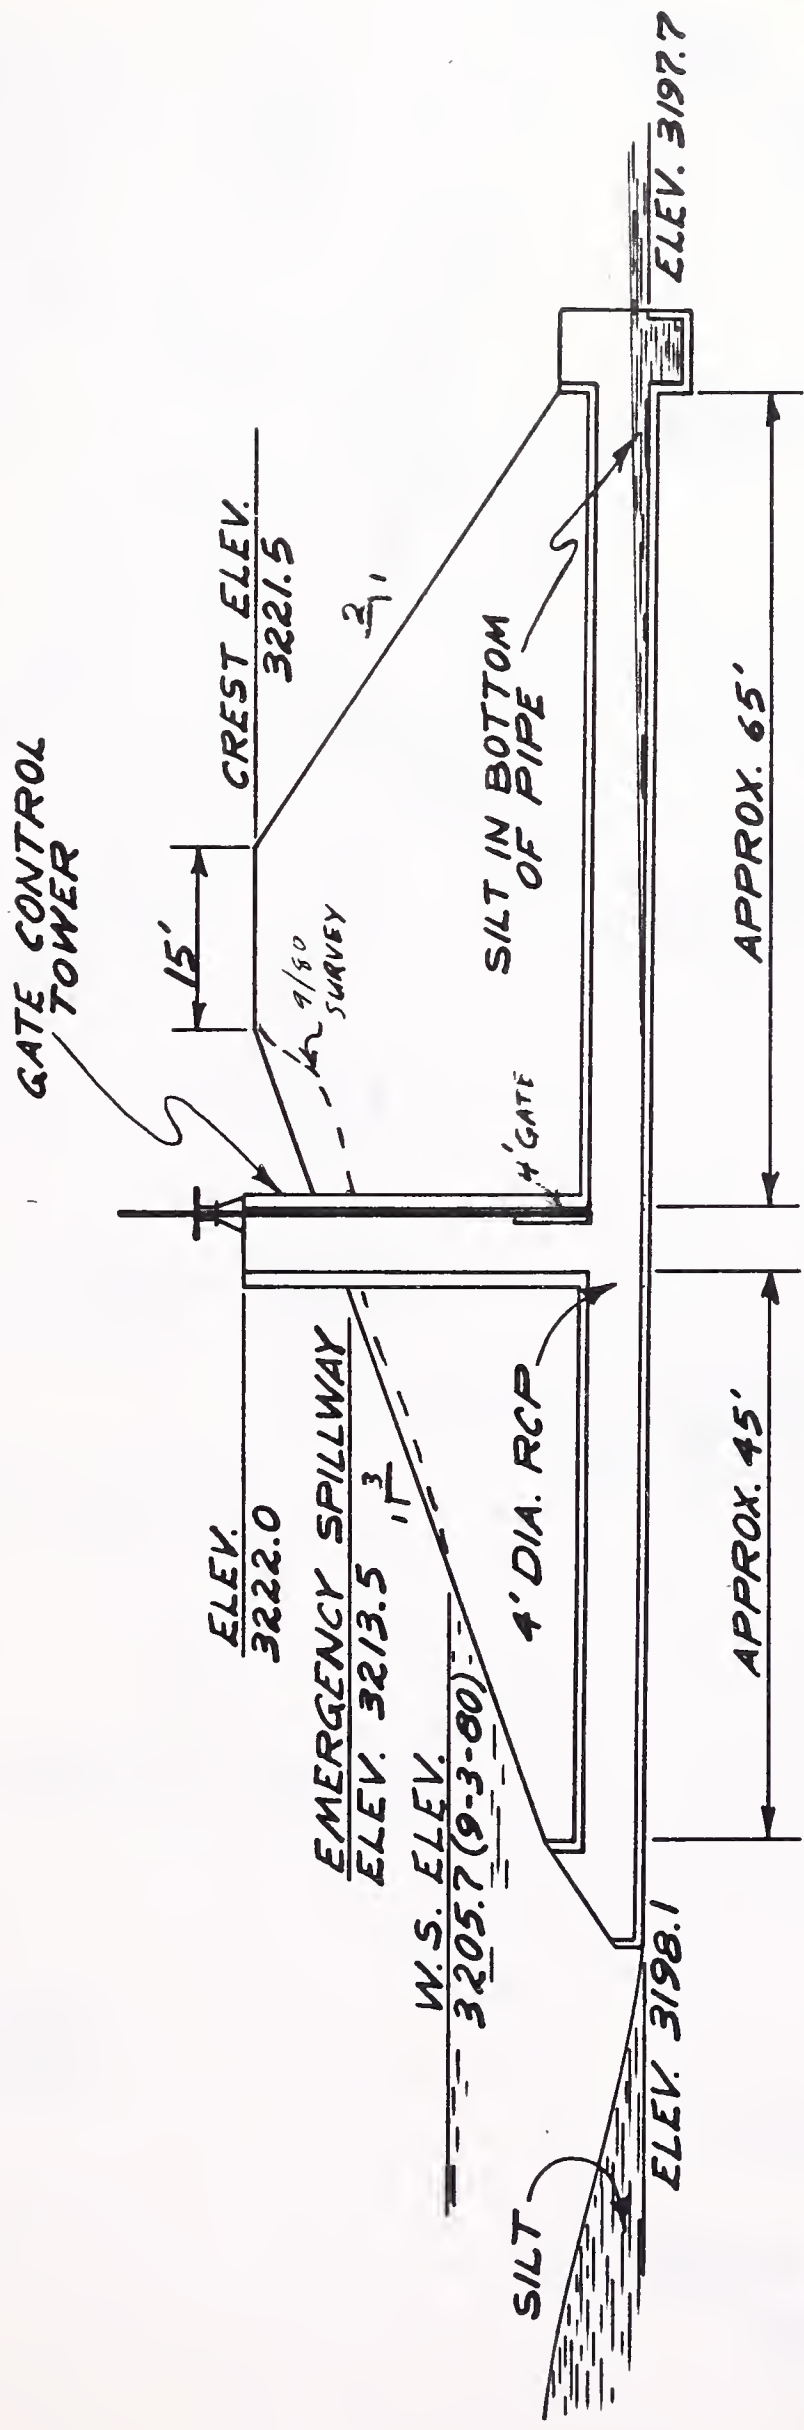
PLATE -5-  
WAR HORSE DAM  
SECTION AT  
OUTLET WORKS

The outlet works for Warhorse Dam(s) is located in the Main Dam near the center of the embankment (Plate 5). A reinforced concrete gate tower located upstream from the dam crest houses a 48-inch-diameter gate and gate lift mechanism with the top of the tower at elevation 3222.0 feet serving as a gate hoist base. (Photo 10) The control tower functions as a wet well with the gate on the downstream side. A 48-inch-diameter reinforced concrete pipe extends about 45 feet upstream to the lake inlet and about 65 feet downstream to the outlet structure from the gate tower. (Photo 11) The maximum discharge with the lake level at dam crest elevation 3219.5 feet is estimated to be 280 c.f.s., and discharge with lake level at emergency spillway crest (maximum normal pool elevation) is estimated to be 230 c.f.s. The outlet discharge rating was developed assuming a Manning's "n" = 0.015 for aged concrete pipe under full pipe flow conditions.

At the time of inspection, the inlet was underwater. However, the water users present recalled that the channel from the lake to the inlet conduit was filled with silt. The outlet conduit downstream from the gate was inspected and appeared to be in fair condition. The inside of the pipe appeared to have been recently patched with a plastic mortar. The plastic mortar has cracked in several places. There was approximately one foot of sediment in the bottom of the pipe near the outlet, which had apparently deposited as the lake was lowered for this inspection. The bottom of the outlet basin was filled with sediment and the downstream channel showed signs of sediment deposits. Exposed concrete in the outlet basin was in generally poor condition due to cracking and spalling (Photo 11). The concrete in the gate control tower appeared to be in fair condition. Repairs were made in 1971, when exposed concrete deterioration due to weathering had progressed to point of exposure of steel reinforcement. The gate lift mechanism was not tested, however, the water users present stated that the lift mechanism was extremely hard to operate and appeared to be binding. This condition was reported in the May 2, 1979 inspection report by the Montana Department of Natural Resources and Conservation. The binding of the gate and cracking of the outlet conduit may be the result of settlement.
